## 2008 Mini Cooper VIN Inspection Date: May 29, 2019

### **Inspection Information**

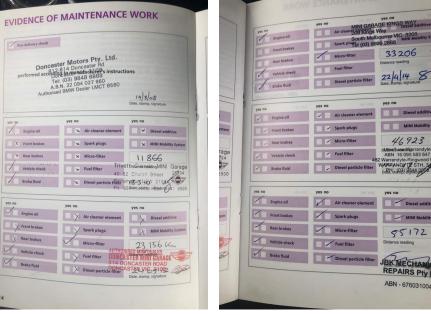
### Service History 2

- **164.** Service History Fair history- not at dealership or specialist the last few years Due for service now
- **165.** Disclaimer / notes Wheels not removed Tested to local conditions and limits

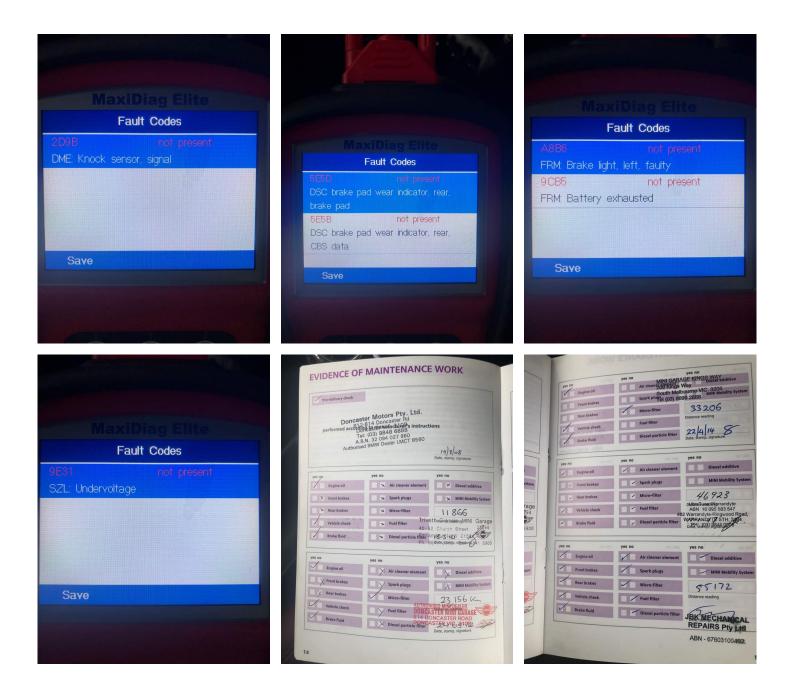
yes no	yes no	yes no	Carlo Carlos
Engine oll	Air cleaner element	Diesel additive	
Front brakes	Spark plugs	Mini Mobility System	
∠ Rear brakes	Z Micro-filter	59 95	
Vehicle check	∠ Fuel filter	Distance reading	
/ Brake fluid	∠ Diesel particle filter	JEK MECHANICAL REPAIRs Pty Ltd Date: date: upget to the second se	
	0	ABN - 67603100492	
yes no	yes no	yes no	
Engine oil	Air cleaner element	Diesel additive	
Front brakes	Spark plugs	MINI Mobility System	
Rear brakes	Micro-filter		2.7
Vehicle check	Fuel filter	Distance reading	REEL
Brake fluid	Diesel particle filter	Date: stamp: signature	
yes no	yes no	yes no	1000
Engine oil	Air cleaner element	Diesel additive	(J- 5.0)
Front brakes	Spark plugs	MINI Mebility System	
Rear brakes	Micro-filter		
Vehicle check	Fuel filter	Distance reading	1XV
Brake fluid	Diesel particle filter		
		Date, stamp. signature
